THE DIALOGUE BETWEEN ANCIENT AND MODERN MATERIALS IN THE RESTORATION OF A COLLAPSED ANCIENT CHAPEL

ANTONIO GALIANO-GARRIGÓS¹, VÍCTOR ECHARRI-IRIBARREN¹, ANGEL-BENIGNO GONZÁLEZ-AVILÉS¹ & MARÍA DOLORES ANDÚJAR-MONTOYA²

¹Building Constructions Department, University of Alicante, Spain.

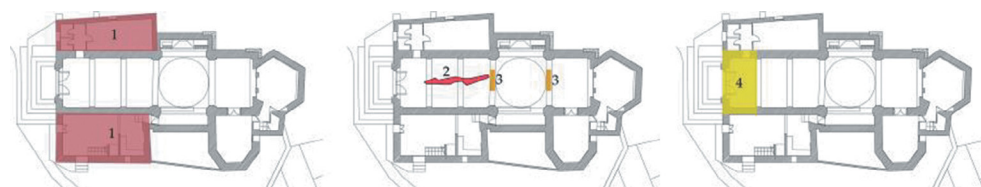
Figure 3: Collapsing process floor plan. 1. Adjoining buildings ruin. 2. Vaults collapse. 3. Damages at toral arches. 4. Choir room collapse.

(Fig. 3). These damages occurred in the main axe of the nave, from the main entrance to the dome, just in the area adjoining the buildings [6].

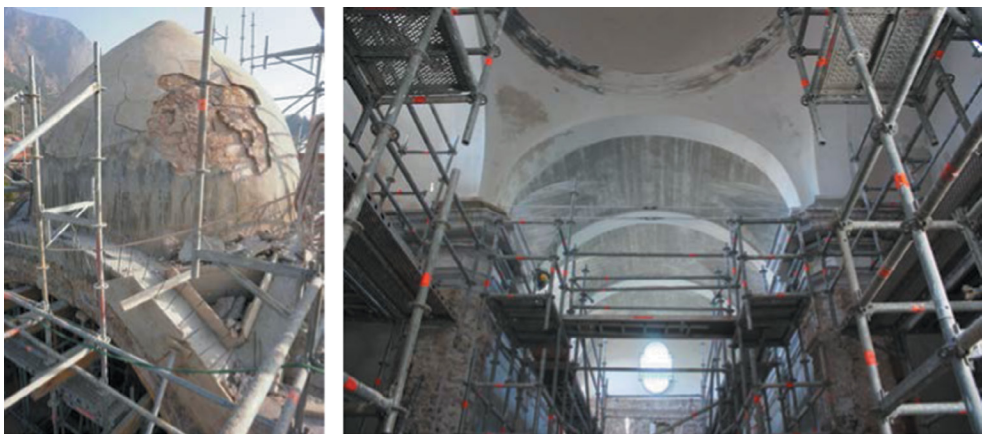
Figure 8: Restoration of the transept dome and interior walls.
